## IN THIS ISSUE

## LOCAL SENTINEL EVENT (1) WRONG LABELING OF SPECIMENS IN LABORATORY LEADING TO TRANSFUSION ERRORS IN TWO PATIENTS

### A DISINFECTION INCIDENT IN OPERATING THEATRE

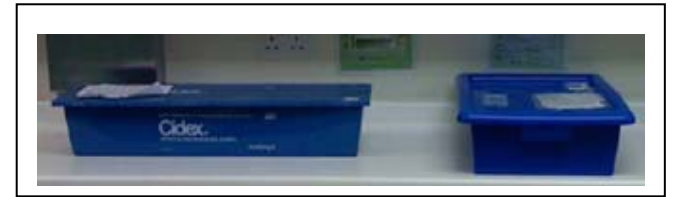
- The use of the same type of trays to hold both CIDEX and sterilized water, without labeling, or written standard procedural guideline.

1. Containers for disinfectants & sterile water must be clearly labeled (of the content).
2. All staff should be well informed of changes in practice before implementation
