RISK ALERT

ISSUE 59 OCT 2020

A Risk Management Newsletter for Hospital Authority Healthcare Professionals

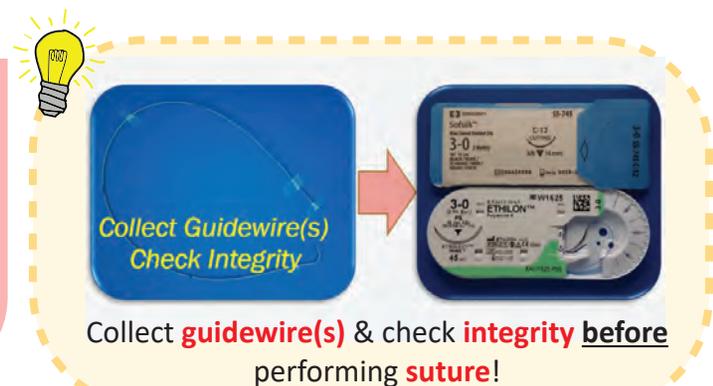
Central Venous Catheter (CVC) Guide Wire

- A patient required intubation and resuscitation. A CVC was inserted for inotropes.
- After 2 attempts of insertion, the attending doctor confirmed the placement of CVC by withdrawing blood from two of 3 catheter lumens.
- At the same time, the patient developed an electrocardiogram change and adrenaline was administered.
- The assistant nurse helped to confirm the patency of the third lumen by flushing 0.9% sodium chloride solution.
- Another nurse asked whether the guide wire had been removed. It was found that a guide wire was placed inside the sharps box and a question was raised as to whether it was the one just used.
- Meanwhile, an urgent chest X-ray was taken. A retained CVC guide wire was identified while reviewing the X-ray.
- The guide wire was removed by interventional radiology.

1. No standardisation of counting all materials used before disposal.
2. No standardisation of procedure set used. A disposable dressing set was used instead of a suture set.
3. Unclear role delineation of an assistant.

Develop a departmental protocol for CVC insertion to standardise the procedure steps and role delineation of each team member.

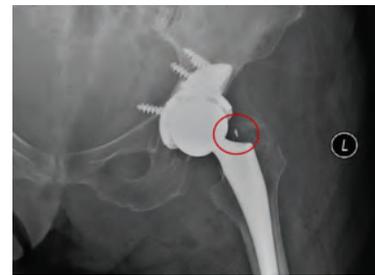
Drill Bit Fragment

- A patient underwent LEFT total hip replacement operation.
- A 2.5mm drill bit was used to create two holes in patient's greater trochanter.
- Completeness was checked and no abnormality was detected after use and during instrument counting.
- A 0.5cm drill bit tip fragment was found missing during instruments reprocessing.
- Post-operative X-ray revealed retained drill bit fragment.
- The patient agreed with the treatment plan for serial X-ray monitoring.

1. Time pressure during the counting process, as more than 1,000 items were involved.
2. High risk of instrument breakage due to a fine drill bit (2.5mm in diameter) on impact with bones and prostheses.
3. The damage pattern of the drill bit.

1. Identify critical instruments used during the operation and adjust the checking threshold. In case of any doubt, involve surgeon to perform double checking.
2. Explore the feasibility of limited or single usage of fine drill bits.
3. Enhance awareness towards the wear and tear of instruments through experience sharing.

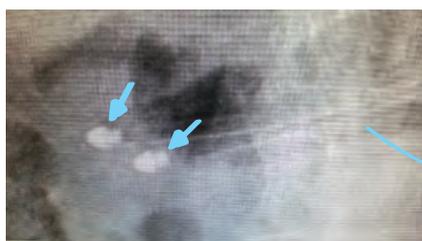
Segment of Silicone Nasogastric Tube

- A patient with multiple chronic illness required feeding via a nasogastric tube (NGT).
- One day, the NGT was found coiled in the patient's mouth. The feeding was stopped and the coiled NGT was removed by an assistant nurse.
- A new NGT was inserted without documentation on the NGT removal and insertion. Feeding was resumed after confirming the placement by X-ray.
- About one month later, the NGT was found coiled in patient's mouth again. The NGT was removed, reinserted and documented.
- Post-procedure X-ray revealed an abnormal opacity, and the NGT was then removed with X-ray taken. The same radio-opaque line was shown in the X-ray image.

- Oesophago-gastro-duodenoscopy was performed, and a 35cm long broken silicone NGT segment was found and removed. An Entriplex feeding tube was inserted for feeding.
- All previous X-ray images were reviewed, and it was found in one of the images a vague double radio-opaque line under the diaphragm. However, without the context of possible retained NGT, the broken segment was difficult to be identified.

1. The NGT was frequently found coiled in the patient's mouth; the patient also munched any content inside her oral cavity increasing the chance of breaking the NGT.
2. Upon removal of the coiled NGT, there was no checking of the integrity, especially the presence of the tip of the tube.
3. Lack of consistent practice for documentation of NGT removal.

1. Strengthen the practice of checking integrity, especially the presence of the tip of the NGT upon removal.
2. Align the practice of documentation for NGT insertion and removal, with compliance monitored.

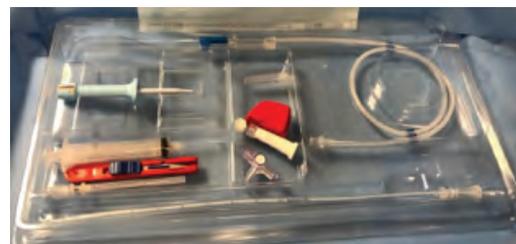
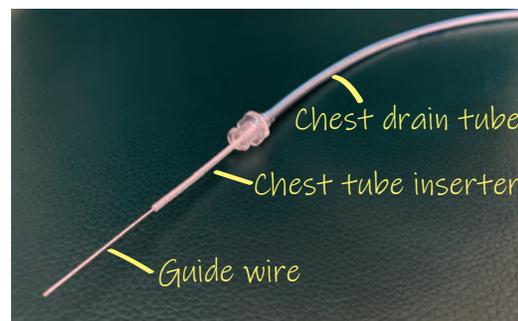
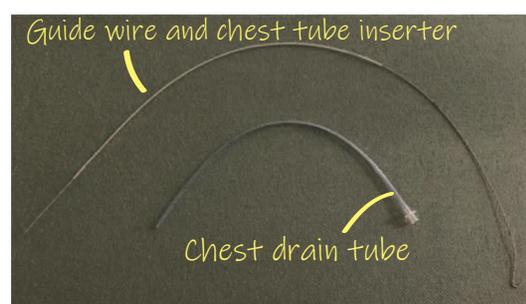
Chest drain kit set

A Chest Drain Set Guide Wire

- Bedside chest drain insertion was performed for a patient with pleural effusion. A chest drain set was used and the procedure was performed uneventfully.
- Post procedure chest X-ray revealed a retained guide wire.
- The guide wire should have been withdrawn with the chest tube inserter (inner sheath) together in one piece after placement of the chest drain tube was confirmed.
- However, only the chest tube inserter was removed and the guide wire was left in-situ without being noticed.
- Another chest drain insertion procedure was performed with the retained guide wire removed. The guide wire was checked and confirmed intact.

1. The doctor had time constraints to attend the scheduled out-patient consultation session.
2. Guide wire and chest tube inserter were presumed to be removed together in one piece.
3. Countercheck of guide wire after procedure was not performed.

1. Concentrate on performing and assisting the procedure especially during critical steps.
2. Perform the "SIGN OUT" procedure and countercheck the number of instruments used together with "Pointing and Calling".
3. Conduct regular training on chest drain insertion for doctors and nurses.
