RISK ALERT

A Risk Management Newsletter for Hospital Authority Healthcare Professionals

Sentinel Events (SEs) (Q2 2024)

Serious Untoward Events (SUEs) (Q2 2024)

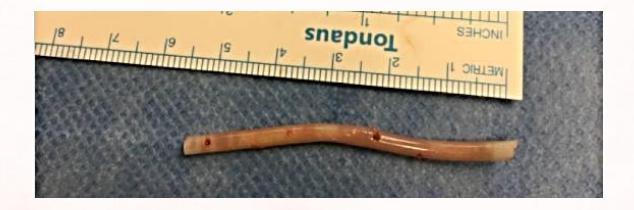
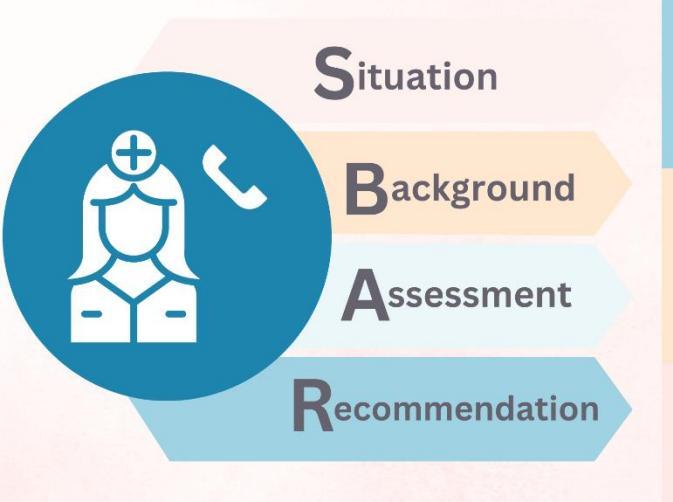
On post-operative day 4, a nurse removed the drain and encountered mild resistance. The nurse noticed that the tip of the drain was missing with irregular cut end. The operating surgeon was called to enquire about the shortened end, and the surgeon explained that the tip had been cut between the side holes during the operation. No further clarification was requested regarding the irregularity of the cut end.

X-ray revealed a segment of linear opacity. A computer tomography (CT) scan confirmed a 5.5 cm radiopaque foreign body at the posterior column of L4. A surgery was performed to remove the retained drain.

- Establish a handover system to measure and document length of the drain inserted in operating theatre, verify length of drain segment removed in ward against the operation record
- 2. Implement a structured communication process between interdisciplinary teams using Situation, Background, Assessment and Recommendation (SBAR)
- 3. Procure **drains with different lengths** to avoid drain cutting

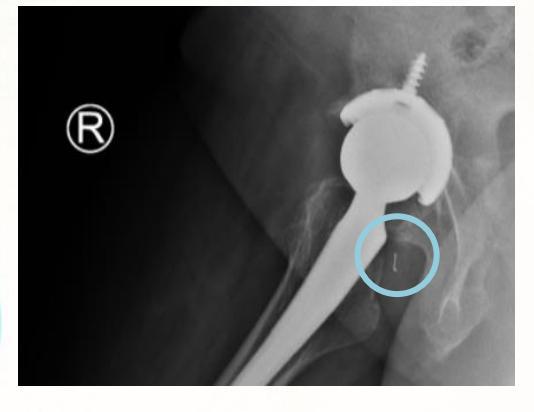
Figure 2. 6mm Metallic Density

At a follow-up appointment, a 6mm curve radio-opacity over lesser trochanter was identified. A subsequent CT confirmed the 6mm metallic density close to the right hip joint (Figure 2). The patient opted for conservative treatment.

When a retained foreign body is suspected, early investigation, follow up of abnormal result and open disclosure should be considered with reference to the clinical condition

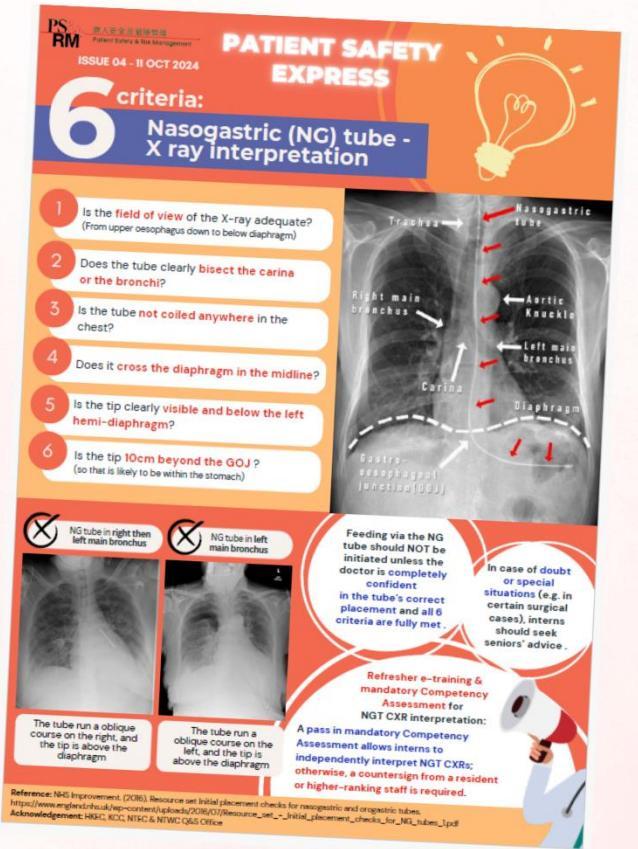
Nasogastric tube was found in the patient's bronchus

A tetraplegic patient had a nasogastric (NG) tube replaced, with a chest x-ray (CXR) ordered. After the tube's position was confirmed through a pH test, feeding was commenced. However, the CXR did not clearly show the tip of the NG tube, and an intern reviewing the CXR did not identify the tube's incorrect placement. Subsequently, the patient's condition deteriorated. Immediate resuscitation was performed and the NG tube was found to be misplaced in the left-sided bronchus. The patient was transferred to Intensive Care Unit (ICU) for further care.

- The incident occurred despite the nurses had confirmed the NG tube position by the pH test before feeding. In retrospect, the NG tube was mistakenly inserted into the left bronchi and the tip of the NG tube might have entered the left pleural cavity. With the existence of possibly infected pleural effusion, **false-positive result** to the pH test might have occurred
- To widen the use of CXR to confirm the position of NG tubes, in view of the possibility of false-positive results of pH test
- To enhance training and education for doctors on radiological confirmation of NG tube position and recognition of abnormality related to NG tube position
- 4. To introduce a new and **specific X-ray examination request** in the clinical management system to ensure radiological image quality for NG tube confirmation
